Map & Site Photographs to accompany
Comparison of Alternatives **TABLE A-6**
(Section 3 Northbridge (Plummer's Landing))

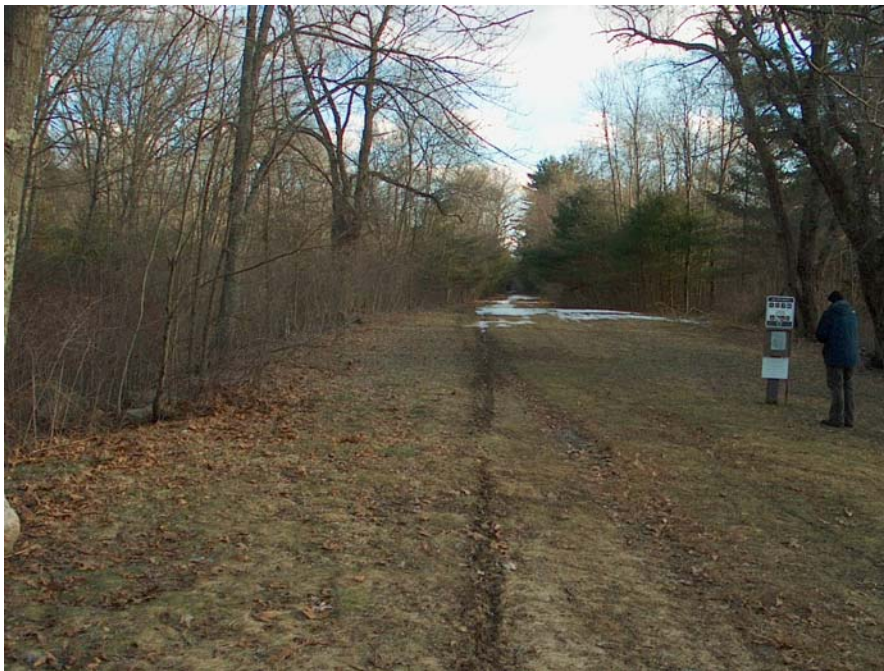
Photo 1: Looking south along the existing Plummer's Trail.
Photo date February 19, 2008

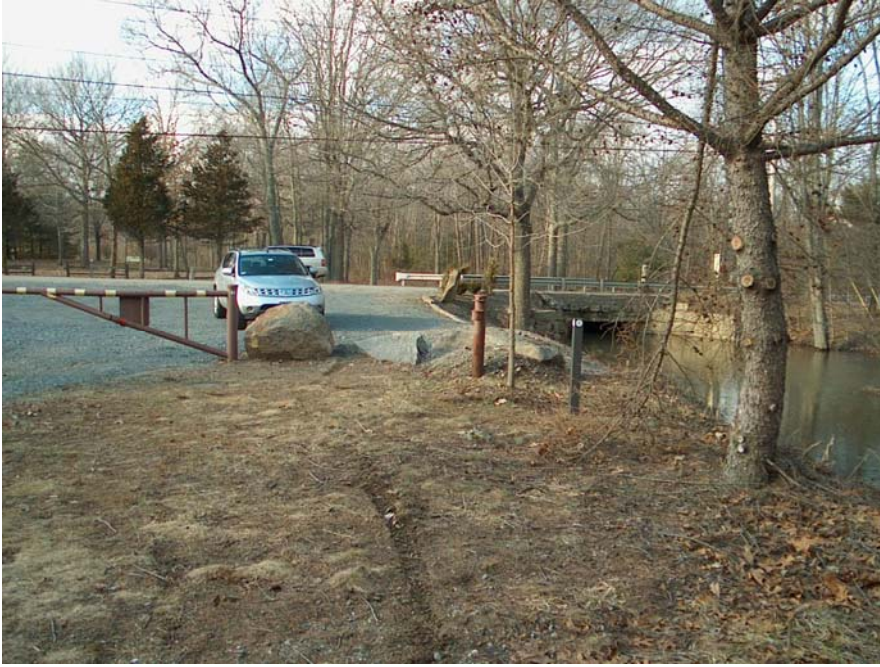
Photo 2: Looking north along the existing Plummer's Trail at the Plummer's Landing parking area. Photo date: February 19, 2008

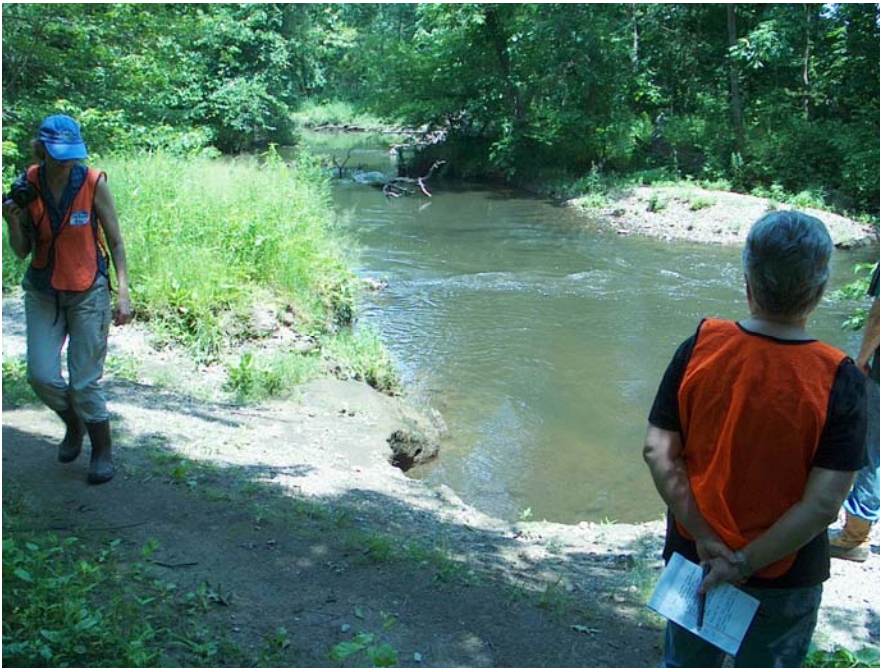
Photo 3: Looking east at an eroded portion of the existing Plummer's trail. The Blackstone River has breached into the canal in this area, and the resulting canal flow appears to be scouring the existing trail embankment. This would need to be repaired if the bikeway would be on this alignment. Photo date: July 1, 2008
